**SLOPE STABILITY STUDY
452 RAGLAN STREET
COLLINGWOOD, ONTARIO**

**REPORT NO.: 4688-17-GD (R)
REPORT DATE: DECEMBER 6, 2021**

**PREPARED FOR:
EDEN OAK MCNABB INC.
833 HURONTARIO STREET
COLLINGWOOD, ONTARIO
L9Y 0G7**

**Re: Slope Stability Report
452 Raglan Street, Collingwood, Ontario**

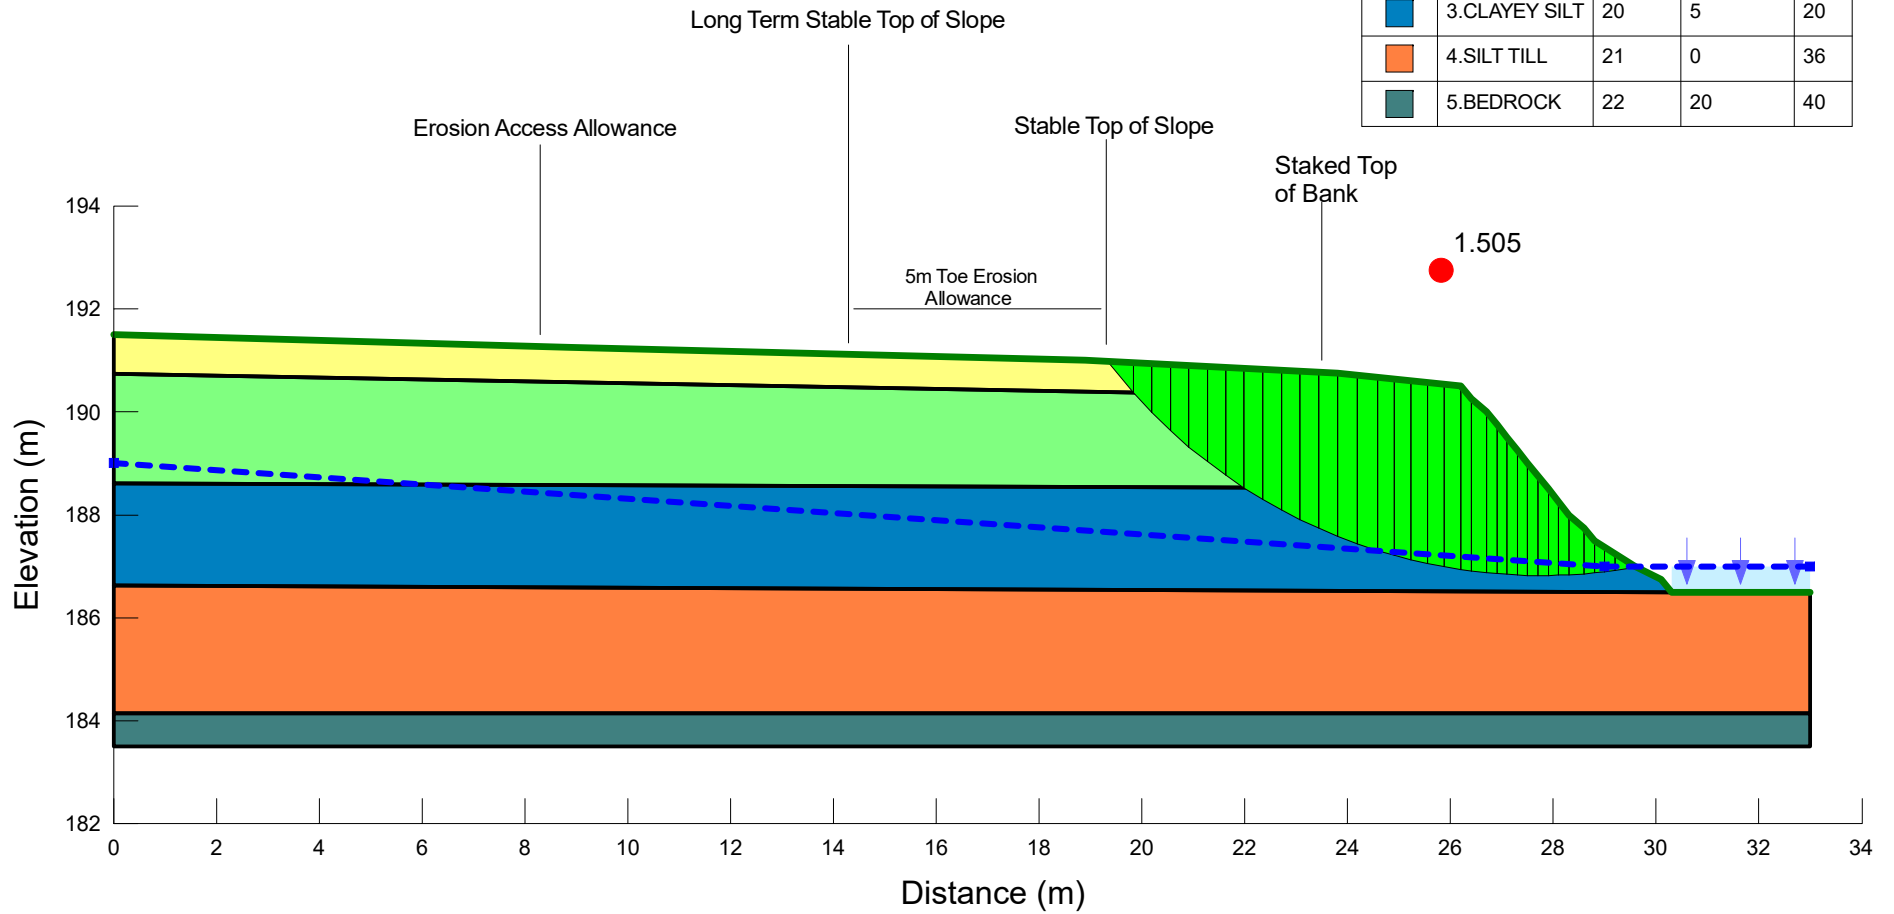
SLOPE/W	4688-17-GD (R)	452 Raglan Street, Collingwood
Section A	Figure No. 1	
2021-12-07	1:147

The results of the slope stability analyses are presented on Figure Nos. 1 and 2. At Sections A-A and B-B, the intercepts for the slip surfaces, with factors of safety of 1.5 or higher, are at distances of 5.3m west and 1.1m east of the existing top of the bank.

The above analytical values indicate that the long term stable top of slope will be at distances of 10.3m and 6.1m, from the existing top of bank at Sections A-A and B-B, respectively. The development setback will be at distances of 16.3m and 12.1m, from the existing top of bank at Sections A-A and B-B, respectively.

Based on the above conditions, the total setback of 30.0m from the long term stable top of slope will be required for any development on the site, as required by the Town of Collingwood Official Plan. This would then equate to a total development setback of 40.3m and 36.1m, from the existing top of bank at Sections A-A and B-B, respectively.

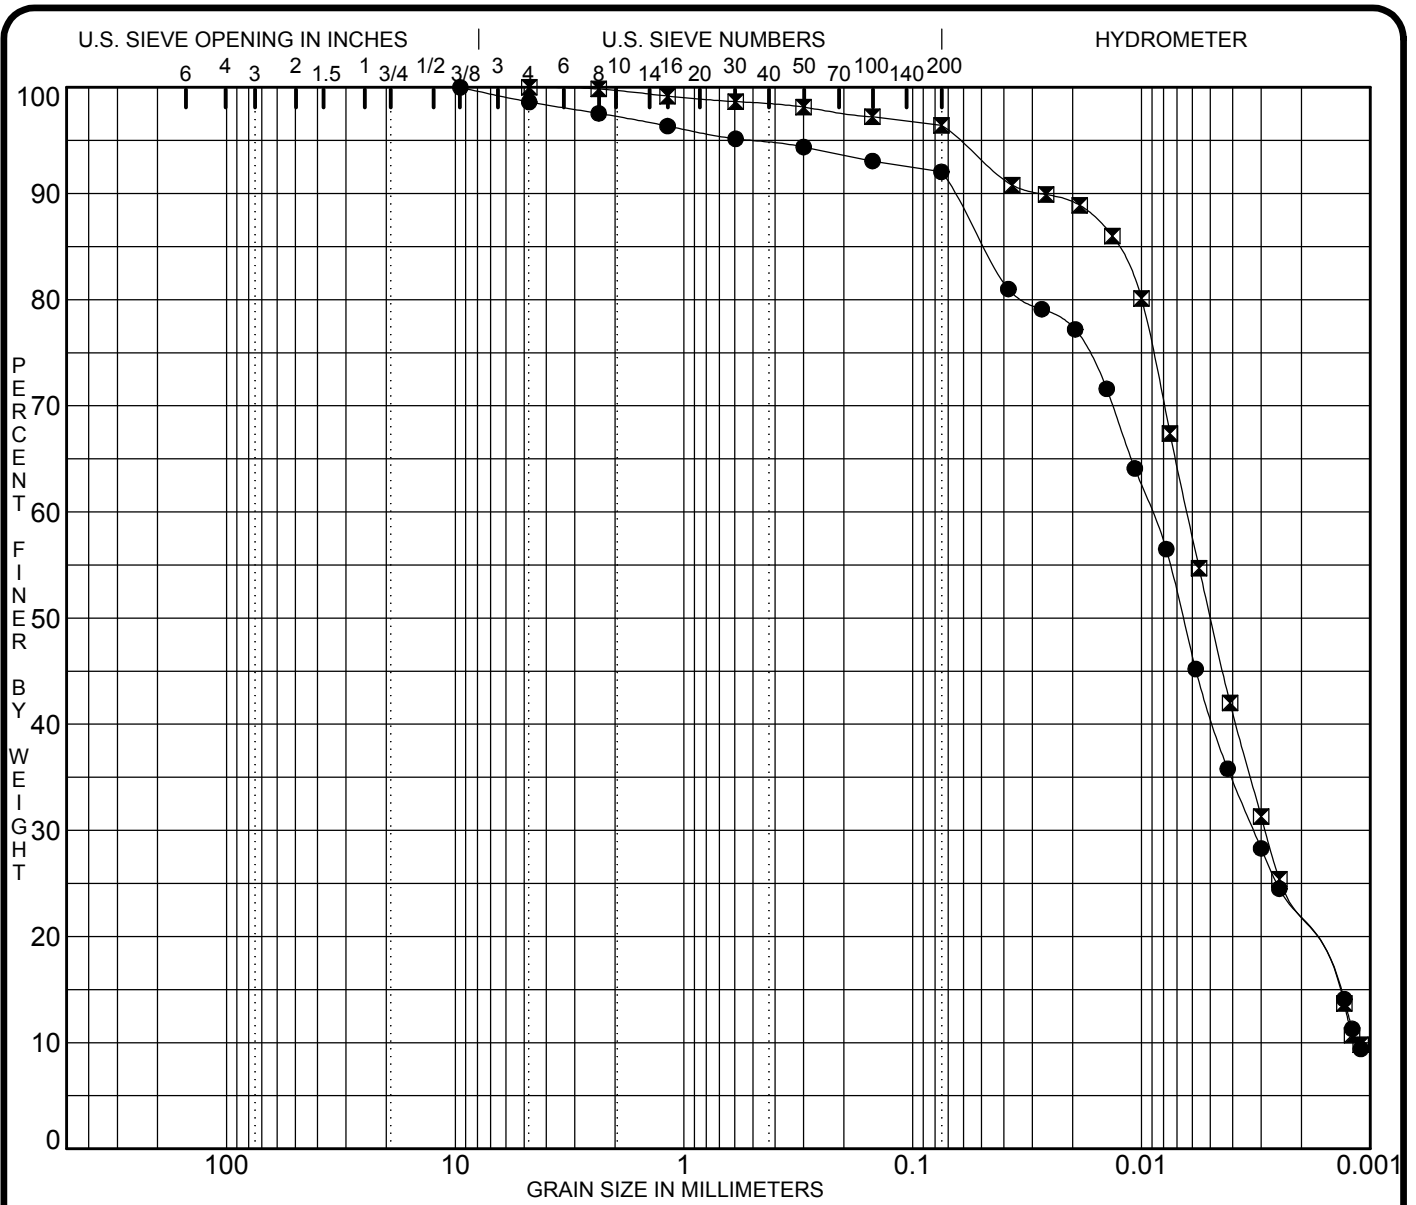
GRADATION CURVES
Toronto Inspection Ltd.

Grain size analysis was carried out on two selected soil samples, obtained from Boreholes BH-23 and BH-24, at depths of 3.0m, using mechanical sieves and hydrometer. The grain size distributions are shown on the appended Figure No. 3.
