# Meander Belt Width Assessment Pretty River

452 Raglan Street, Collingwood

Report Title: Meander Belt Width Assessment  
Pretty River  
452 Raglan Street, Collingwood

Project Number: PN20044a

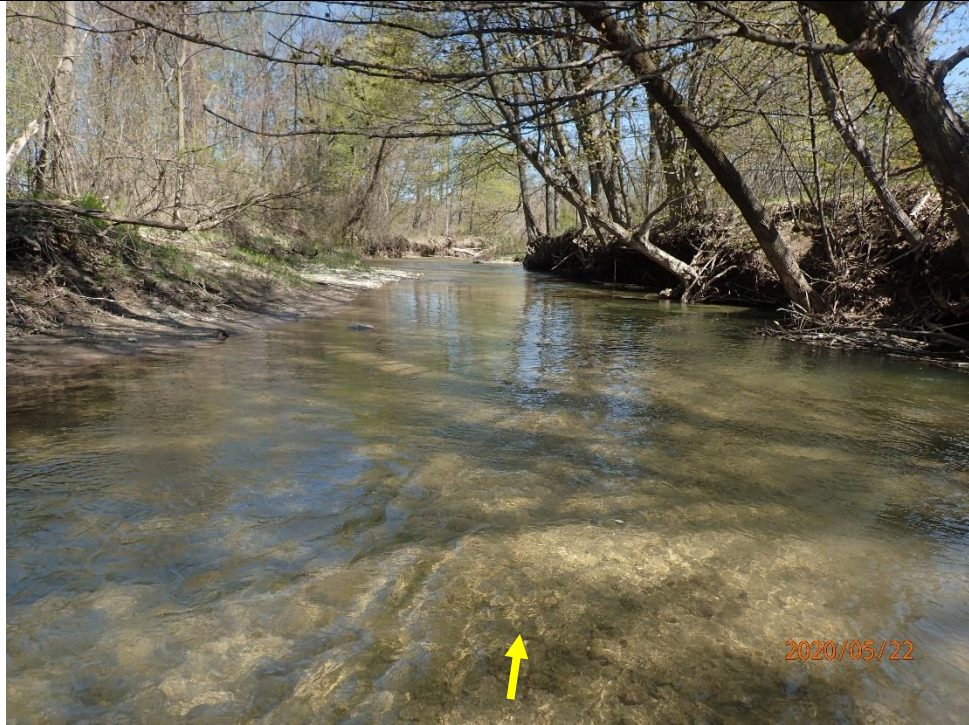
**Photo 1**  
Reach PR-1 – Pretty River, Collingwood, Ontario

Photograph taken looking downstream at the upstream extent of the Reach PR-1. Pretty River flows through agricultural lands with a small riparian buffer.

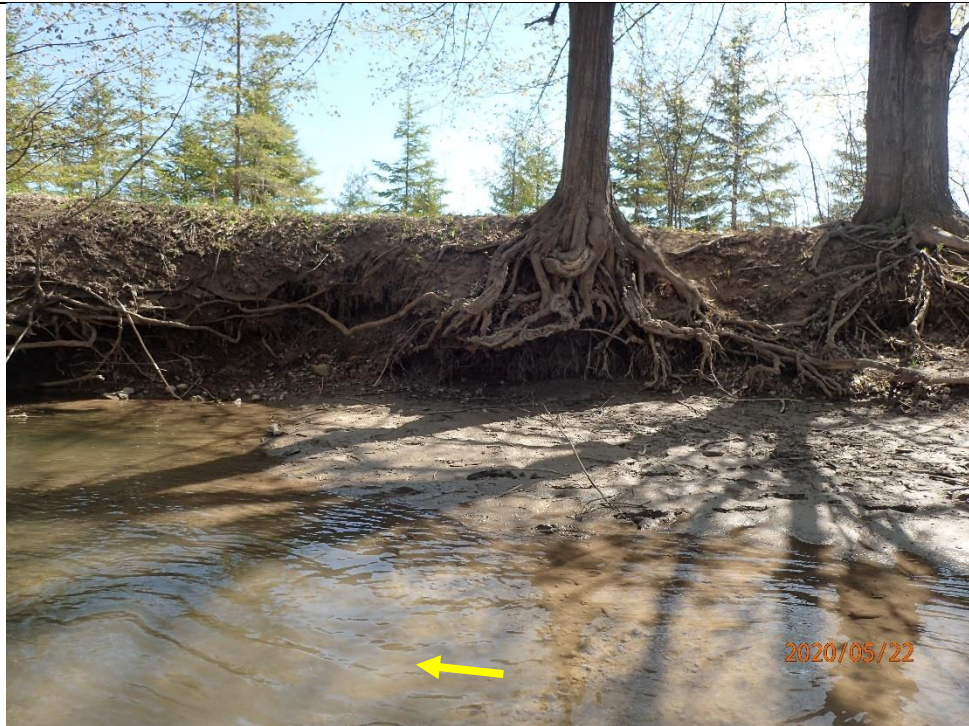
**Photo 2**  
Reach PR-1 – Pretty River, Collingwood, Ontario

Photograph taken of the right bank, exposed tree roots were common throughout the reach. This provides evidence of channel widening indicating the stream is in adjustment.

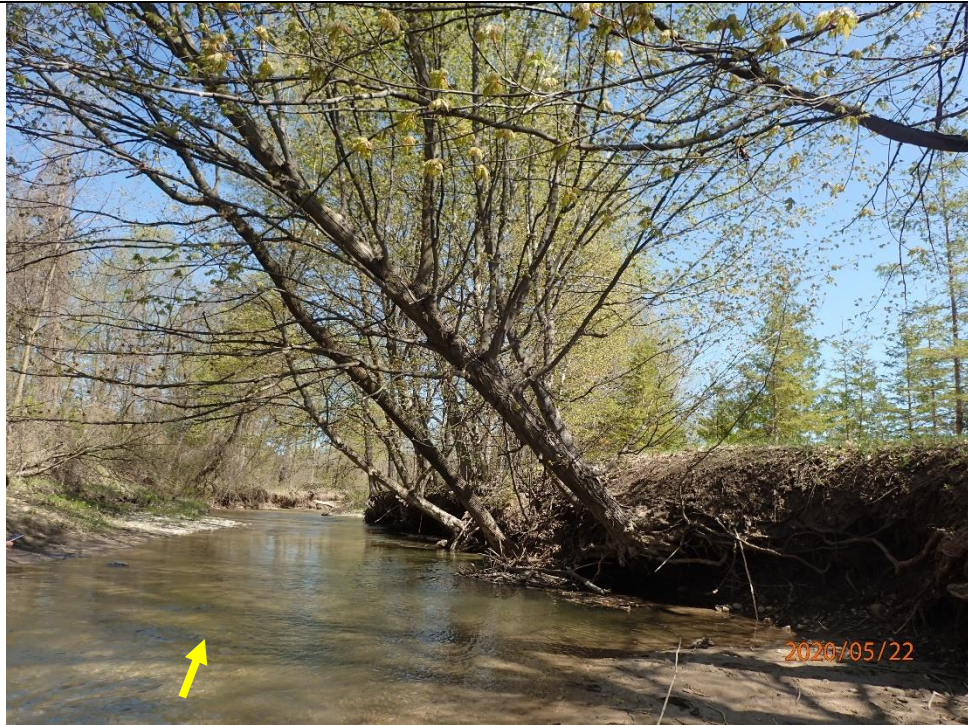
**Photo 3**  
Reach PR-1 – Pretty River, Collingwood, Ontario

Photograph taken further downstream, leaning and fallen trees were commonly identified along the reach, indicating evidence of channel widening.

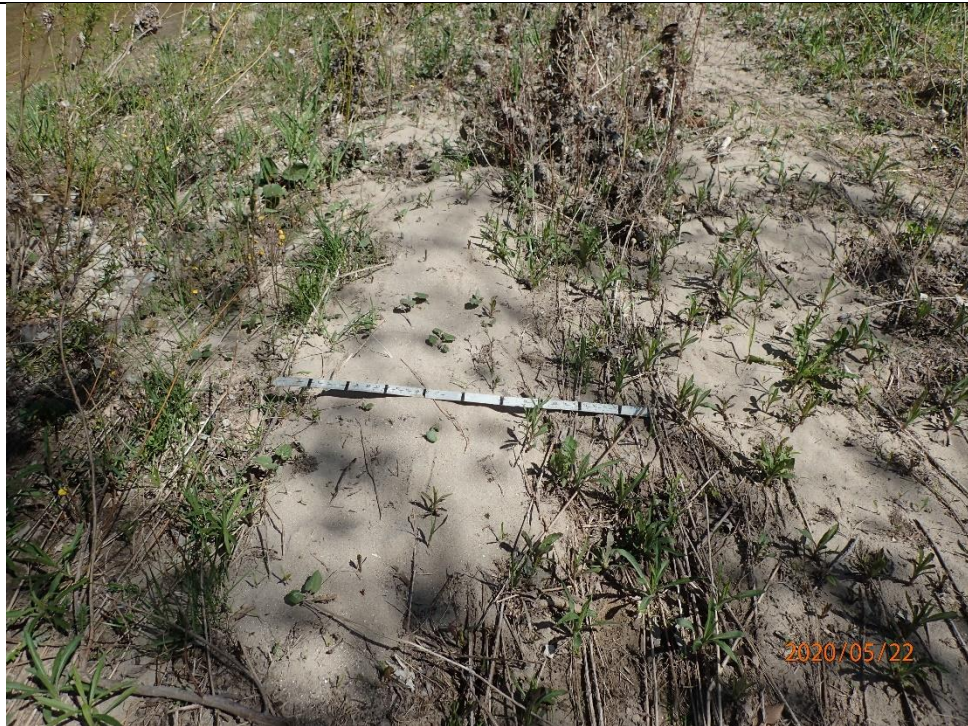
**Photo 4**  
Reach PR-1 – Pretty River, Collingwood, Ontario

Photograph taken of a fresh large sand deposit along the top of low banks. Deposition in the overbank zones was common within the reach providing evidence of aggradation.

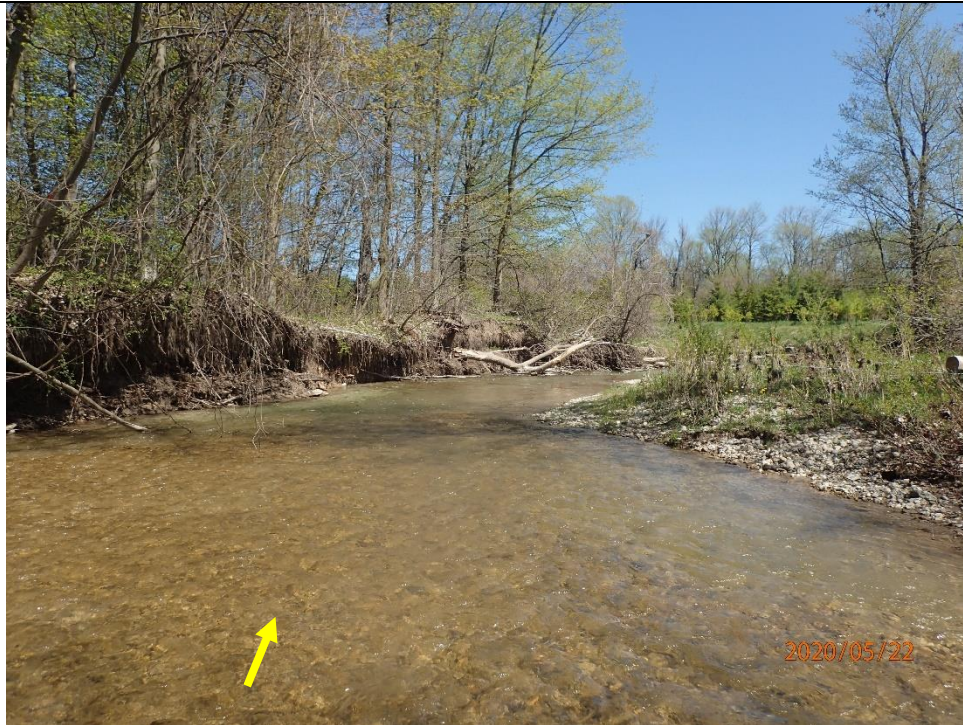
**Photo 5**  
Reach PR-1 – Pretty River, Collingwood, Ontario

The riparian zone was approximately 1 to 4 channel widths and provided fragmented coverage through the system. There was mature (>30 years) tree species within the riparian zone.

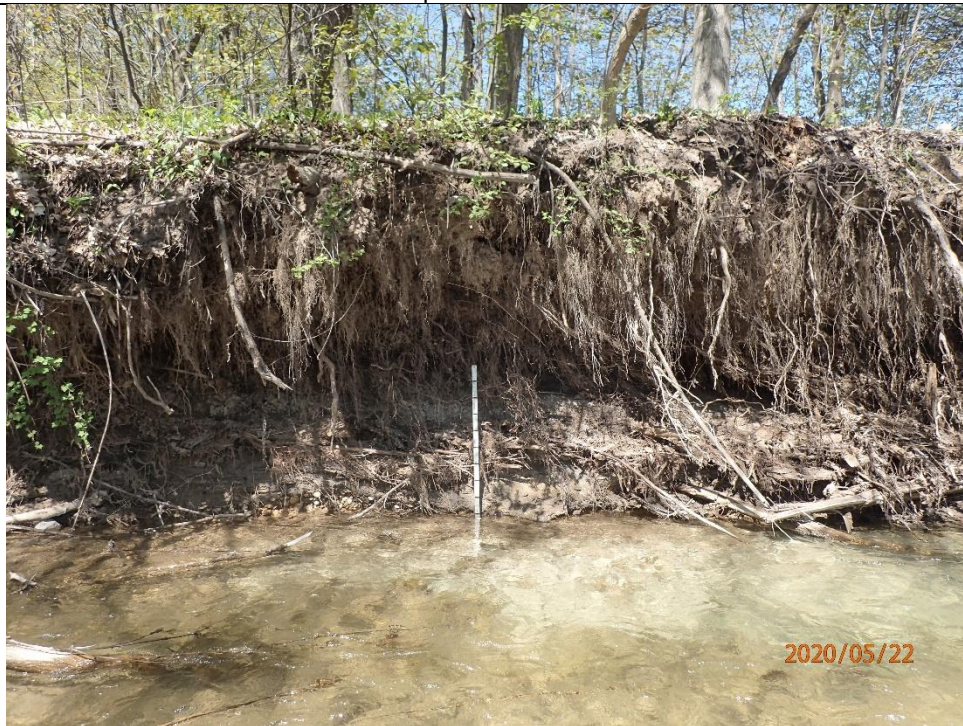
**Photo 6**  
Reach PR-1 – Pretty River, Collingwood, Ontario

Photograph taken looking at the left bank. Large undercuts were common (approximately 1.65 m in depth), this is an indication of erosion leading to channel widening.

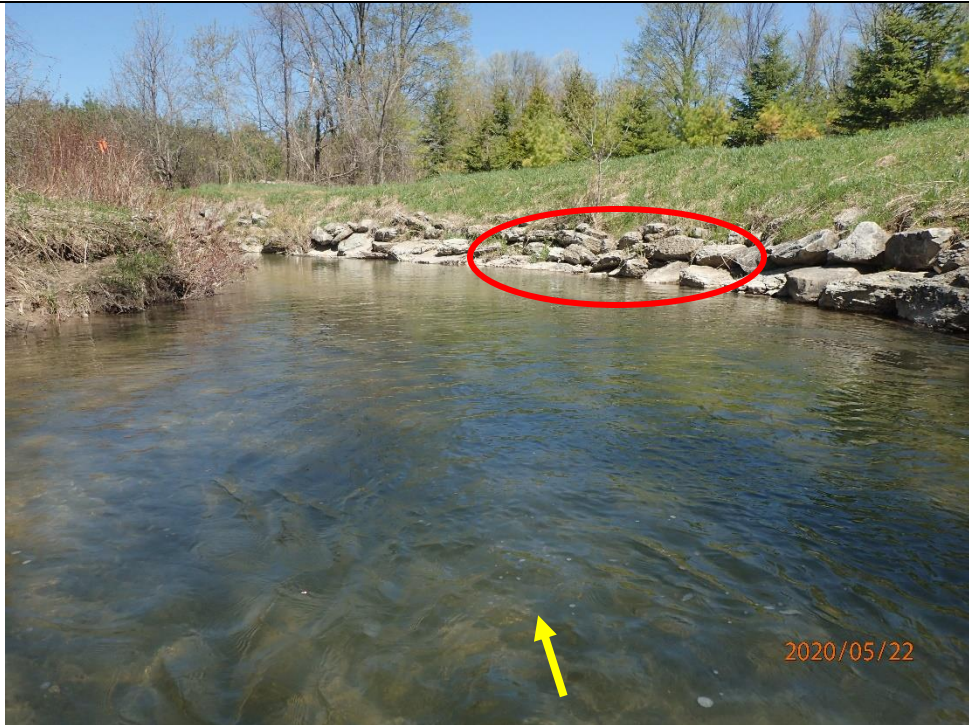
**Photo 7**  
Reach PR-1 – Pretty River, Collingwood, Ontario

Photograph looking downstream, bank stabilization (cobble and boulders) were present along the outside of meander bends to prevent erosion.

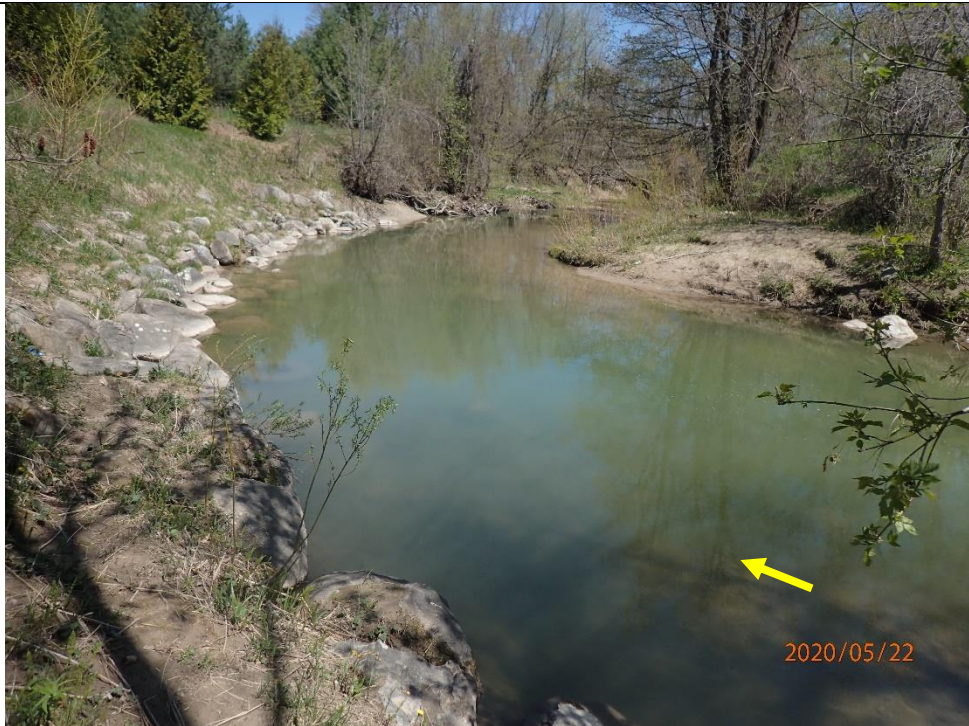
**Photo 8**  
Reach PR-1 – Pretty River, Collingwood, Ontario

Riffle/pool sequencing was good throughout the reach. Pools had an average depth of approximately 1.5 m. Siltation was identified within the pools indicating aggradation within the channel.

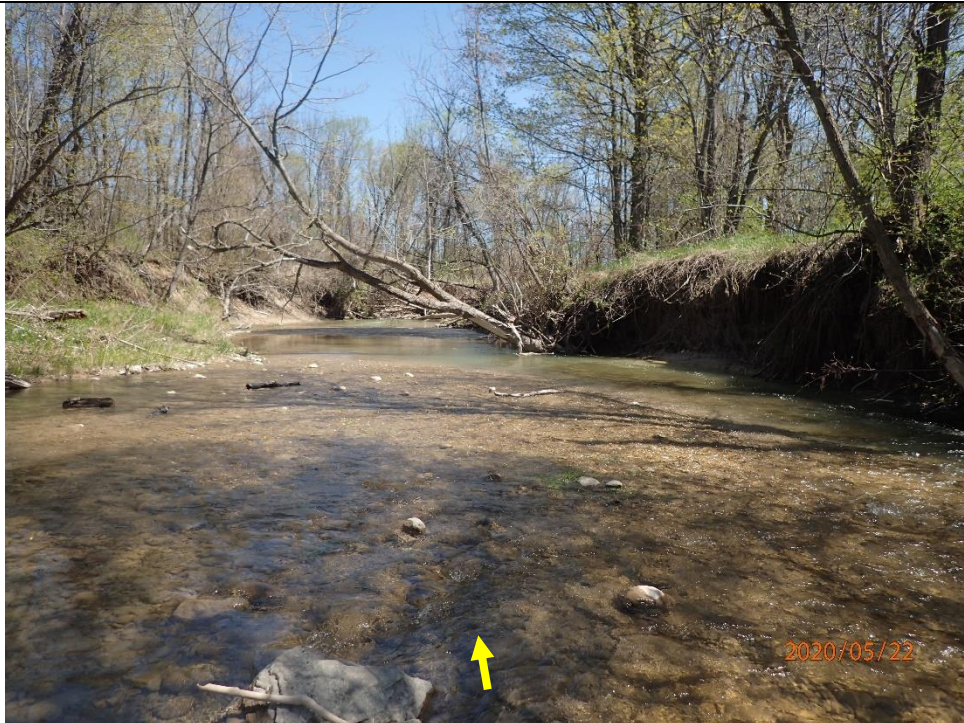
**Photo 9**  
Reach PR-1 – Pretty River, Collingwood, Ontario

Photograph taken facing downstream. Riffles were composed of coarse embedded materials such as cobbles, gravel and small boulders, providing evidence of aggradation within the channel.

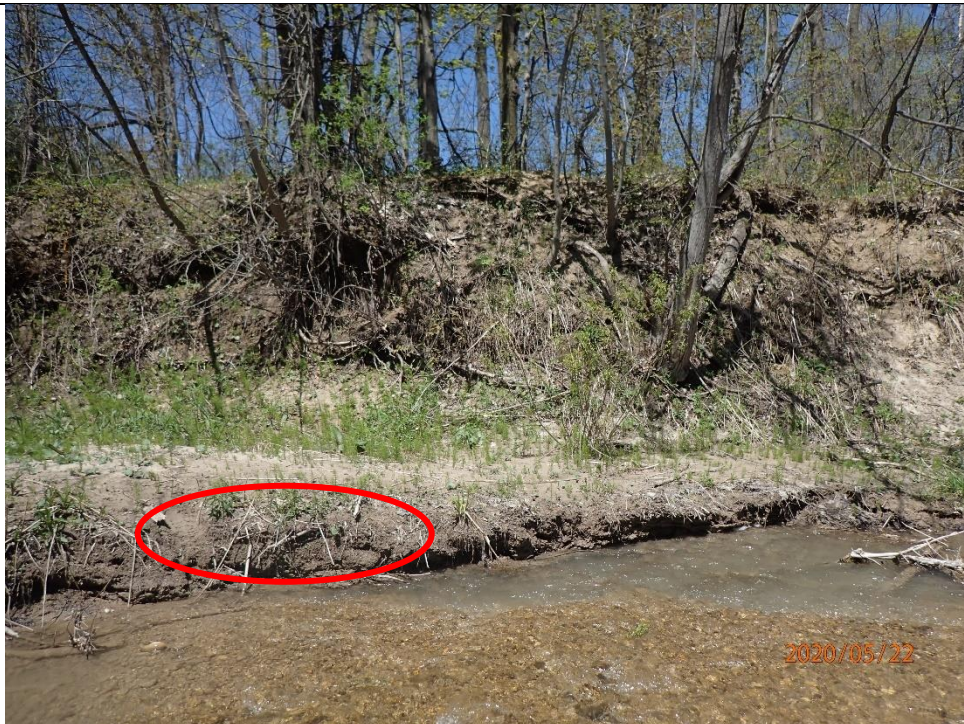
**Photo 10**  
Reach PR-1 – Pretty River, Collingwood, Ontario

This photograph illustrates a well-vegetated, confined section of the watercourse. Erosion scarring on the base of the channel bank is indicative of widening processes.

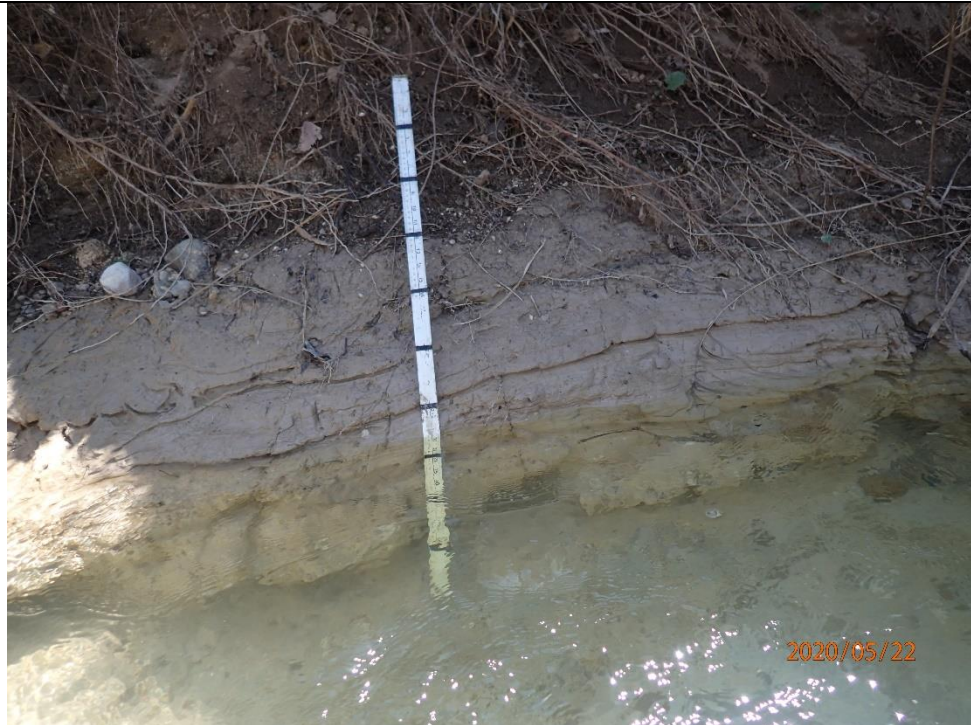
**Photo 11**  
Reach PR-1 – Pretty River, Collingwood, Ontario

Photograph taken of the right bank showing exposed till. The channel was worn into undisturbed overburden / bedrock this is indicative of degradation.

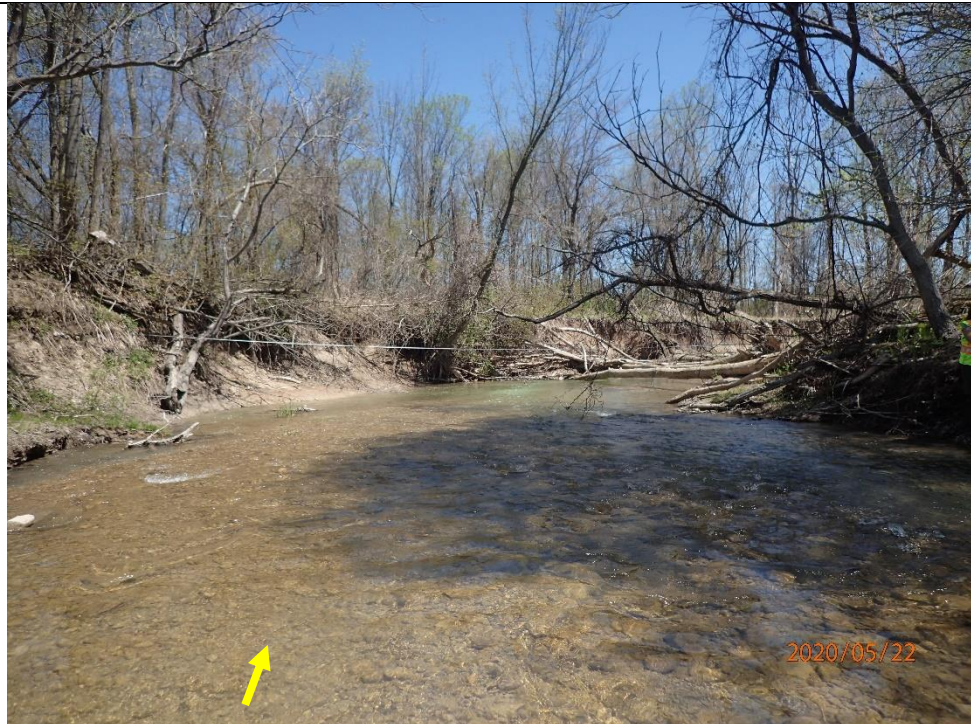
**Photo 12**  
Reach PR-1 – Pretty River, Collingwood, Ontario

Channel bank material consisted of clay/silt and gravel. The reach was identified as being a "partially-confined" system with some sections of bank exceeding 2 m in height.

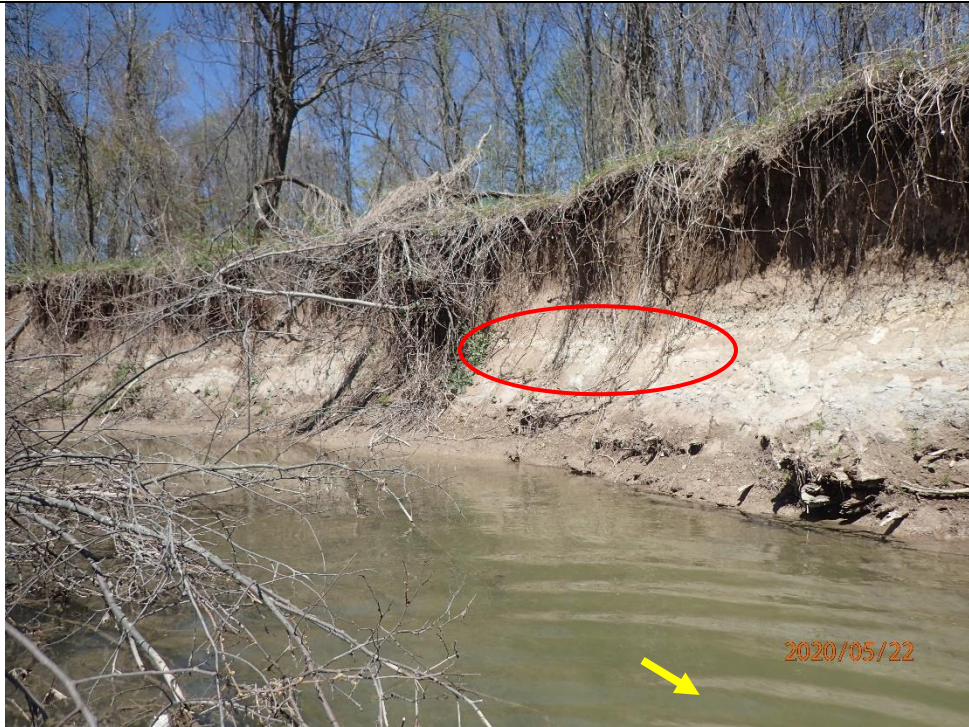
**Photo 13**  
Reach PR-1 – Pretty River, Collingwood, Ontario

Photograph taken facing upstream. The channel had unstable slopes and bank failures were observed frequently. Suspended armour layer was visible (circled here) throughout the reach.

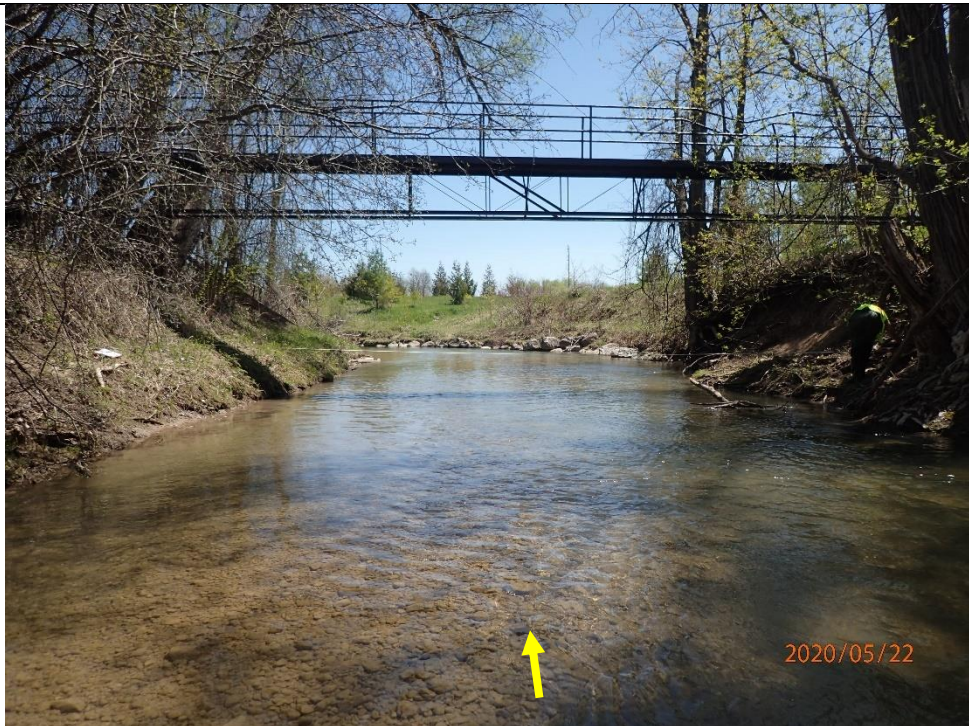
**Photo 14**  
Reach PR-1 – Pretty River, Collingwood, Ontario

Bank angles ranged from 60° to 90°. Further, bank erosion was identified through 60% to 100% of the reach.

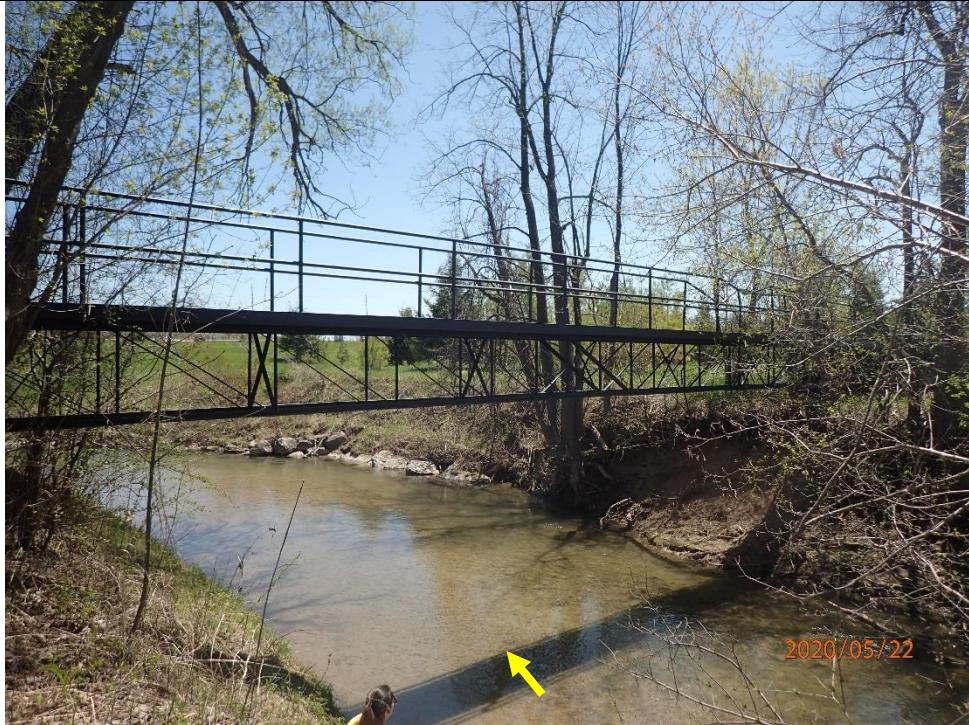
**Photo 15**  
Reach PR-1 – Pretty River, Collingwood, Ontario

There were two crossings throughout the reach, a pedestrian bridge crossing and a driveway crossing. The pedestrian bridge was approximately halfway through the reach. Bank erosion was evident at this crossing with large, exposed tree roots and undercutting along the slopes. The driveway bridge was at the downstream extent of the reach. This crossing had exposed and worn concrete footings.

Photograph looking downstream at the pedestrian bridge crossing. Throughout the reach there was a low density of woody debris present in the channel.

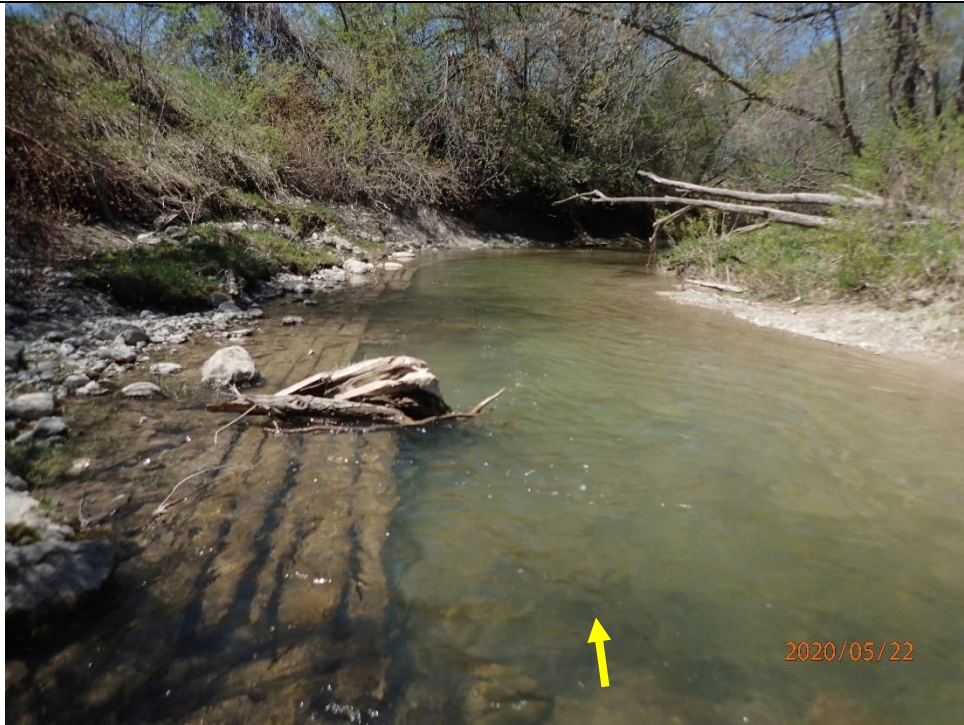
**Photo 17**  
Reach PR-1 – Pretty River, Collingwood, Ontario

Photograph taken facing downstream. Evidence of historical bank protection was visible along the left bank.

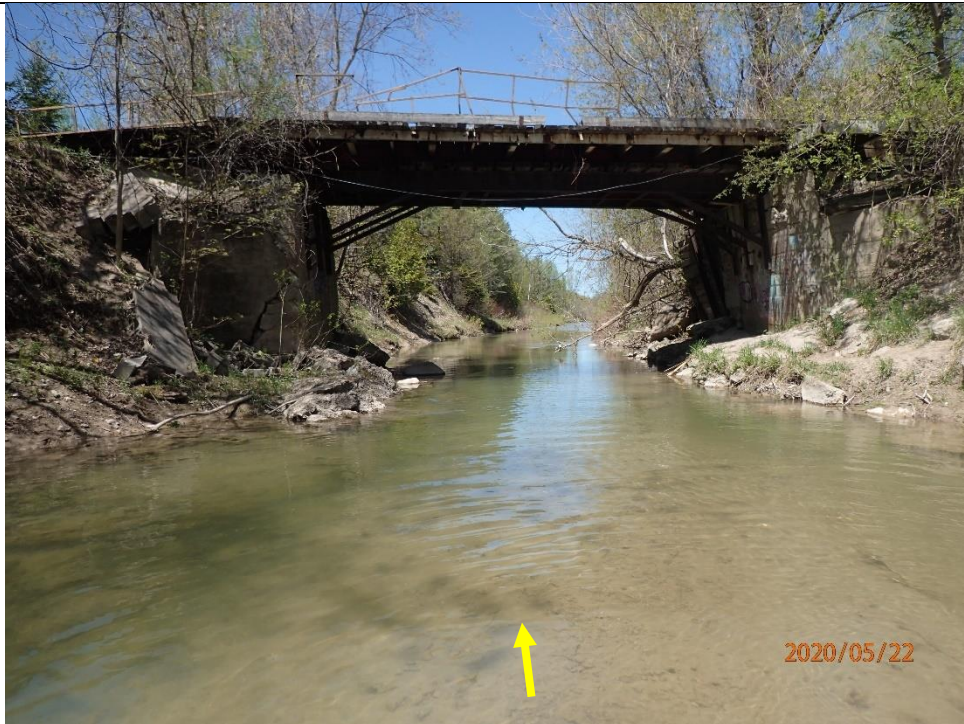
**Photo 18**  
Reach PR-1 – Pretty River, Collingwood, Ontario

Photograph taken at the downstream extent of the reach where a driveway bridge crosses the watercourse. Bankfull width and depth were 11.54 m and 0.76 m, respectively.

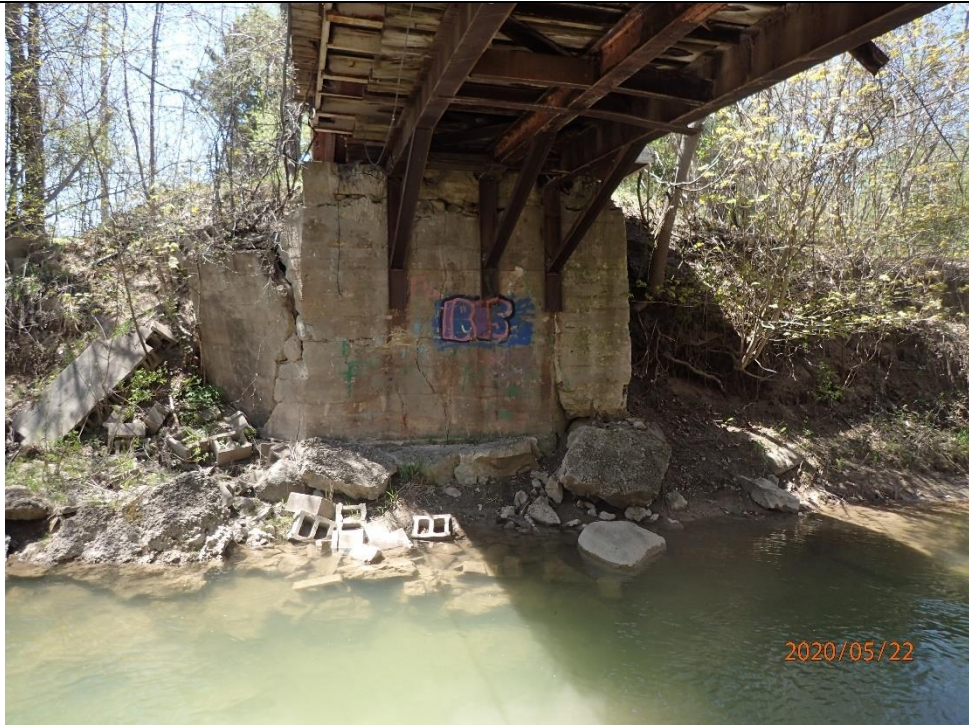
**Photo 19**  
Reach PR-1 – Pretty River, Collingwood, Ontario

Photograph looking at the exposed and worn concrete bridge footings associated with the driveway crossing. This provides evidence of degradation, which limits overall channel stability.

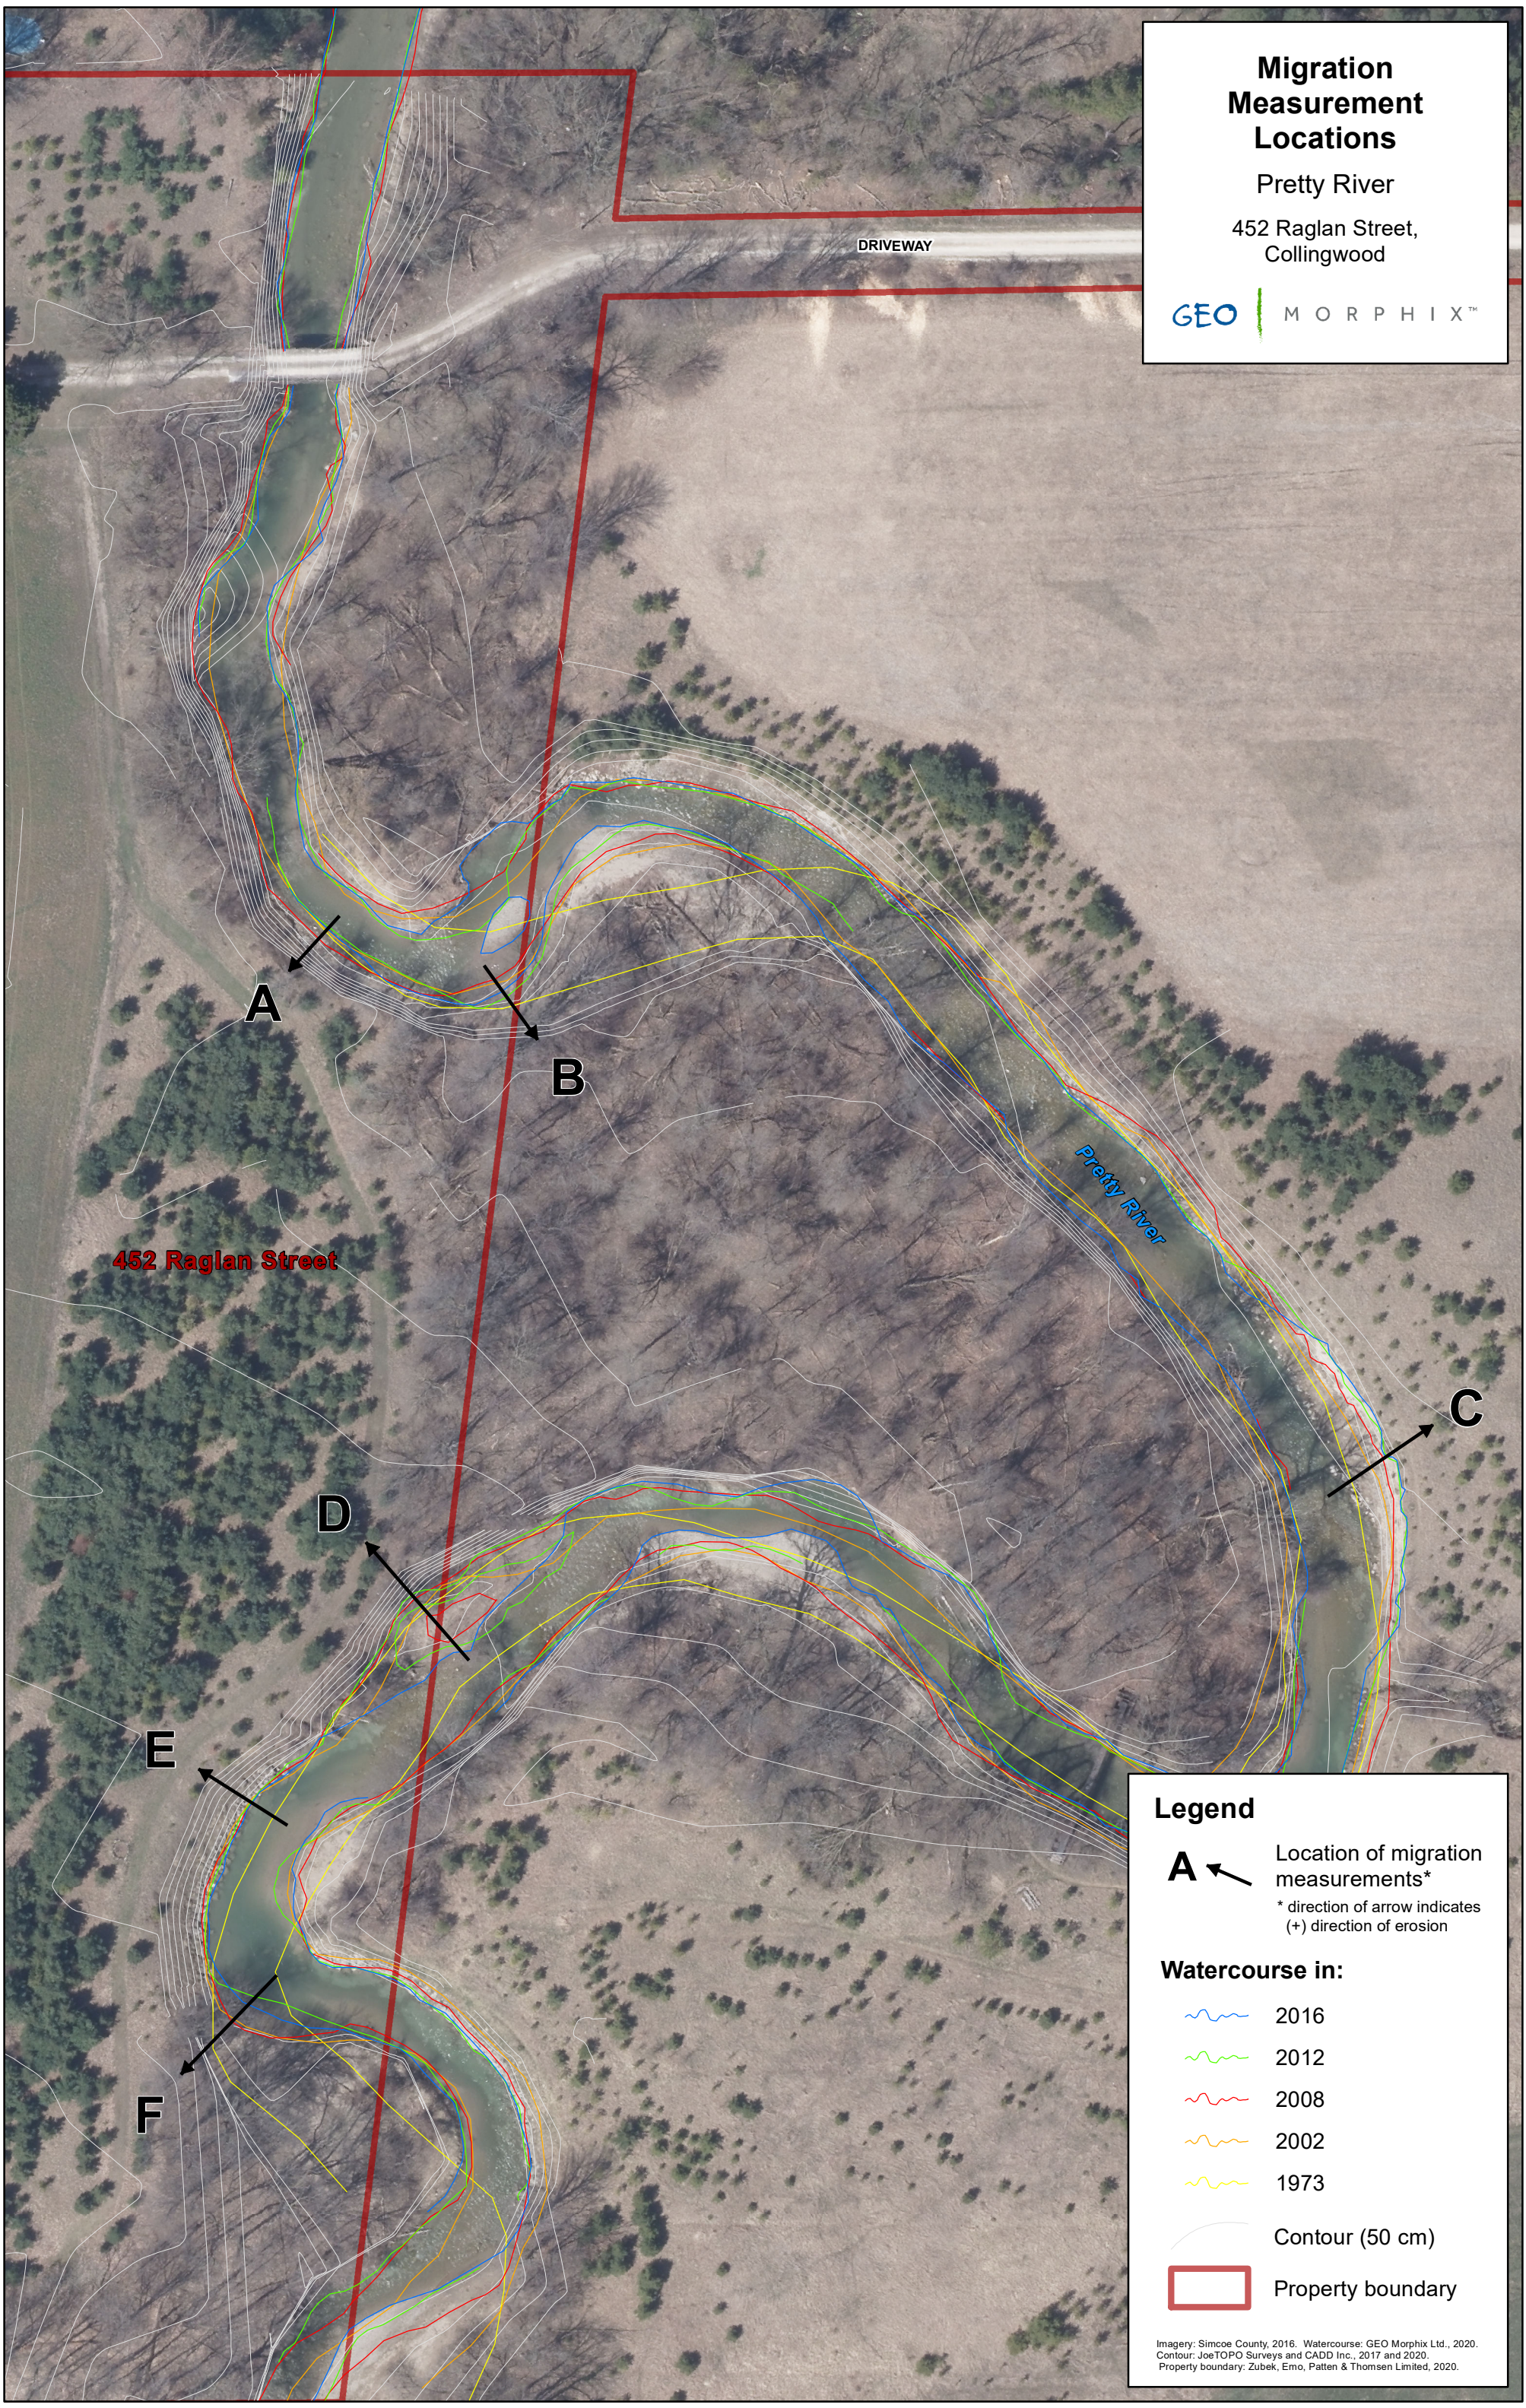
As outlined in **Table 2**, the erosion rate based on averaging the migration rates for Pretty River is -0.032 m/yr. Further, the 100-year erosion rate is -3.22 m. This suggests that migration is within the potential error of the estimates and is illustrating limited lateral migration. The negative values suggest aggradation could be a product of water levels, vegetation encroachment, or rectification errors. Based on the 100-year erosion rate, as well as observations of erosion through **Reach PR-1**, we recommend applying a 5 m erosion setback to the geotechnically long-term stable top of slope. Following MNR's (2001) approach, the 100-year erosion setback of 5 m could be applied to address the erosion hazard where the river is within 15 of the valley toe of slope. It is understood that a preliminary setback of 8 m was proposed by Toronto Inspection Ltd. (2020); however, the 5 m erosion setback could be applied as a less conservative approach. It is important to note that the setback will need to be applied to the long-term stable top of slope for the final constraint mapping.
