**REPORT ON
PHASE TWO ENVIRONMENTAL SITE ASSESSMENT
452 RAGLAN STREET
COLLINGWOOD, ONTARIO**

**REPORT NO. : 4688-17-EB
REPORT DATE : JANUARY 11, 2018**

**PREPARED FOR
URBAN PRO DEVELOPMENTS (COLLINGWOOD) INC.
1885 WILSON AVENUE, #202
TORONTO, ON
M9M 1A2**

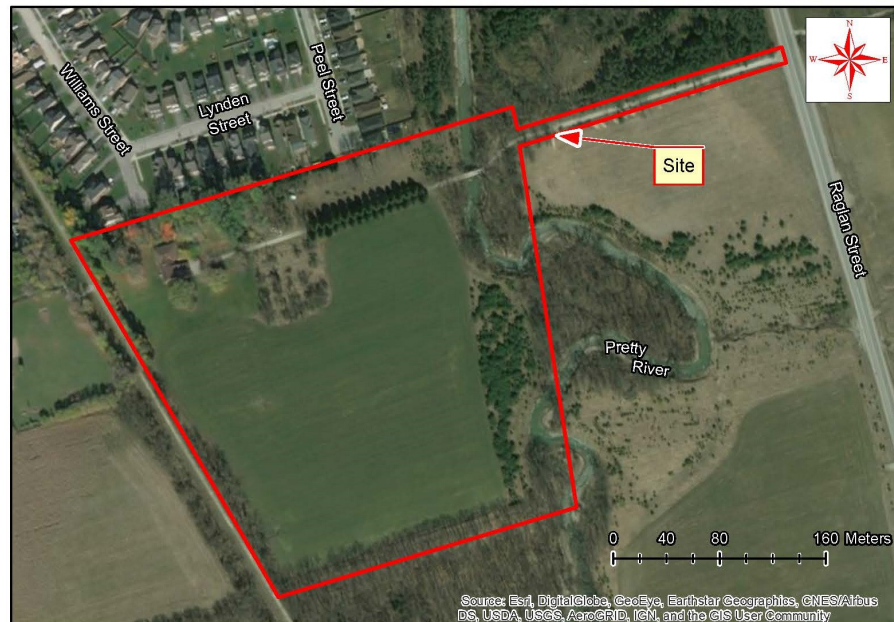
Image No. 1: Aerial image of Phase Two Property (EcoLog ESRI)

At the time of this Phase Two ESA, the north portion of the Site consisted of a single-storey residential building with a full basement (Subject Building), a small storage shed, a driveway with a bridge that crosses Pretty River, and landscaped. Portions of the Site (along the east, south and southwest property boundaries) consisted of natural woodlands, forest areas and a meandering Pretty River. The remaining areas of the Site was used as agricultural land. The Subject Building contained a garage that was attached to the southeast side of the Subject Building and an enclosed pool at the southwest corner. Vehicular access to the Site was a gravel driveway off Raglan Street located on the northeast corner of the Site. The footprint area of the residential building was approximately 570 m² (6,144.78 ft²). An aerial view of the Phase Two property is presented in Image No. 1, below :
