# Meander Belt Width Assessment Pretty River

452 Raglan Street, Collingwood

Report Title: Meander Belt Width Assessment  
Pretty River  
452 Raglan Street, Collingwood

Project Number: PN20044a

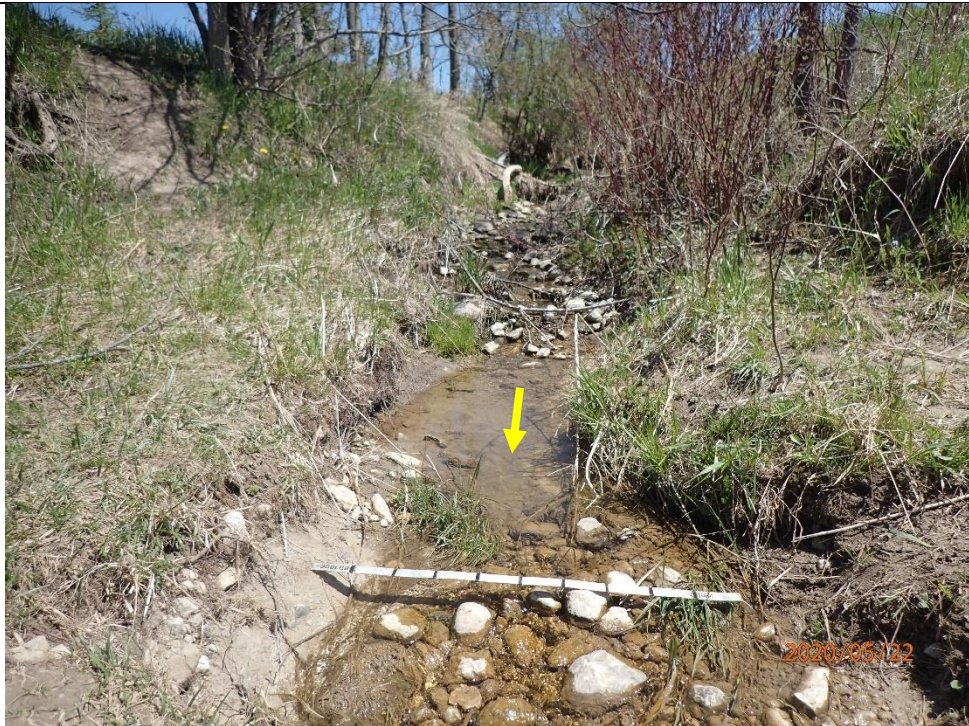
**Photo 17**  
Reach PR-1 – Pretty River, Collingwood, Ontario

Photograph taken looking upstream at the intermittent tributary flowing from Raglan Street into Pretty River.
